SMALL BUSINESS PREVENTS DAMAGE TO INVENTORY THE POOL MAN, INC

Clarksville, Indiana

Project Profile

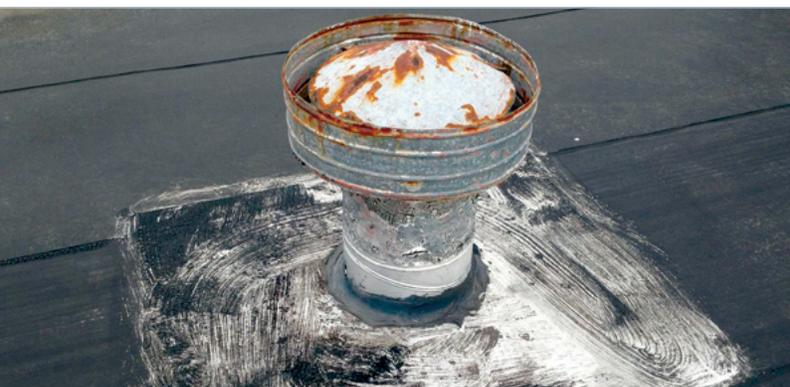
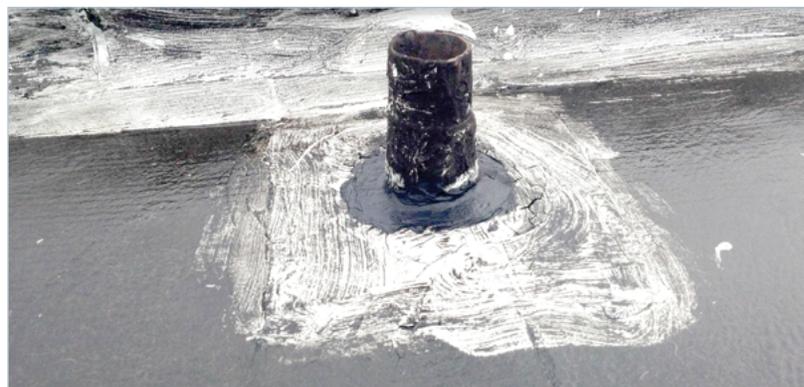
The previous roofing system, a smooth-surface built-up roof, had severe wear and tear around all protrusions and building edges. These areas were given a three-course silicone treatment of coating-fabric-coating to ensure a water-tight seal.

- Power washed the smooth surface built-up roof to remove all dirt and grease stains.
- Swept the roof surface to remove any debris left behind from the power washing.
- Any damaged areas and lap seams were fixed using a 3 course coating-fabric-coating system.
- Protrusions in the roof surface such as vents also received the 3 course system.
- Coated the field of the roof with 100% silicone coating once lap seams and protrusions had dried.

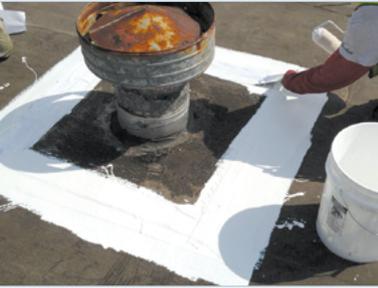
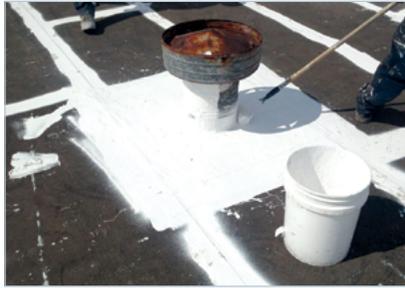
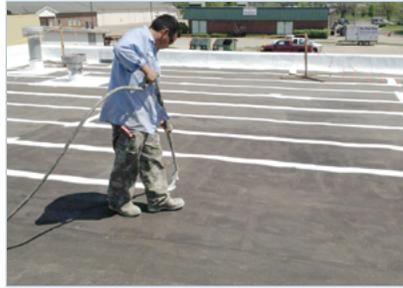
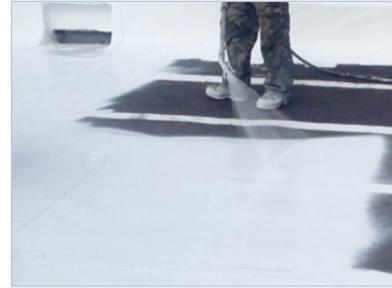
All protrusions in the roof were treated with a 3 course system (coating-fabric-coating) and received coating on the entire fixture. This ensured a watertight seal where the old system was vulnerable to leaks.

Seams in the roofing system received an extra coating of silicone coating prior to coating the field of the roof. The seams are the most leak-prone areas of any roof, so the extra step was necessary for a watertight system.
